Arecibo Telescope Collapse Forensic Investigation

Thornton Tomasetti

July 25, 2022

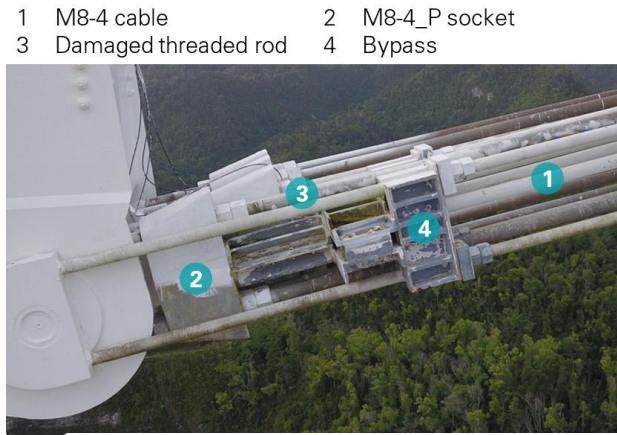
Figure 11: Damaged rod bypass at platform end of cable M8-4
(photo: NAIC Arecibo Observatory, a facility of the NSF).

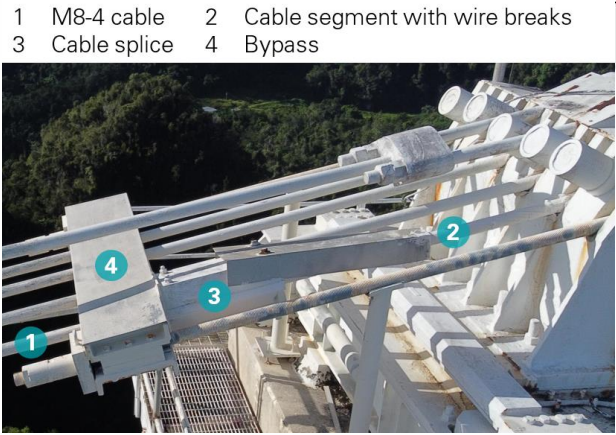
Apart from the second upgrade, three significant changes were made to the cable system. In 1981, one of the original backstays of Tower 12 was replaced after six wire breaks were discovered in the cable over time. Then in 1997, a threaded rod connecting the platform-end socket of cable M8-4 was accidentally damaged while implementing the second upgrade of the telescope. A structural bypass was installed to catch the socket should the damaged rod fail (Figure 11). In 2014, a splice near the tower end of the same M8-4 cable was bypassed after multiple wire breaks were discovered during an inspection (Figure 12).

Figure 12: Cable splice bypass near tower end of cable M8-4
(photo: NAIC Arecibo Observatory, a facility of the NSF).

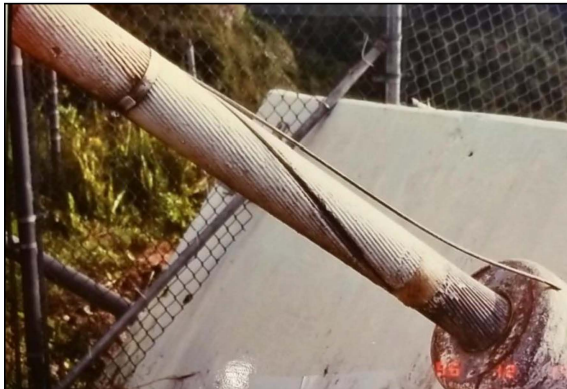
Figure 20: Single wire break observed at ground end of cable B4-1 on 12/12/1996
(photo: NAIC Arecibo Observatory, a facility of the NSF).

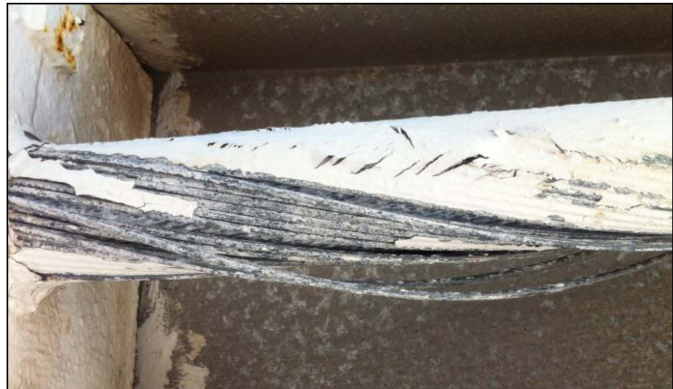
Figure 21: Multiple wire breaks observed at splice near tower end of cable M8-4 on 1/14/2014
(photo: NAIC Arecibo Observatory, a facility of the NSF).

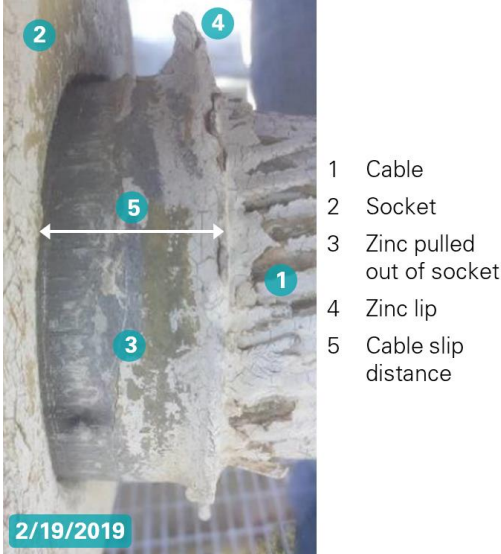
Figure 23: Last known cable slip (1.125 inch) at socket M4N_T, where first cable failure occurred (photo: NAIC Arecibo Observatory, a facility of the NSF).

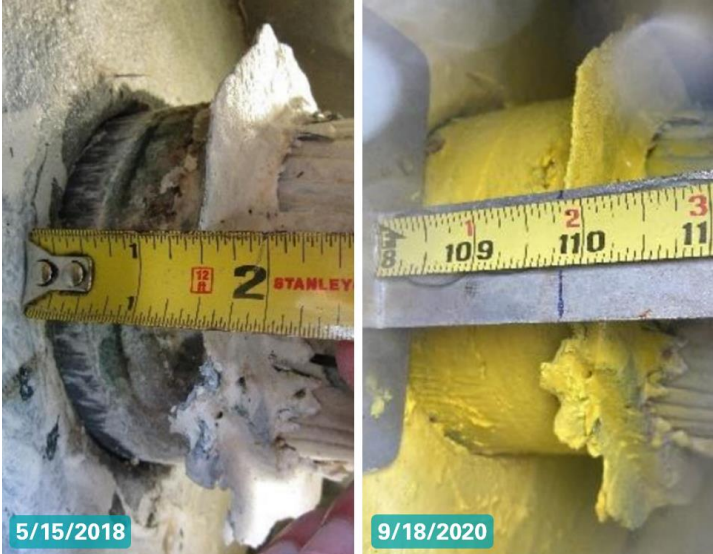
Figure 24: Cable slip increase measured at socket B12W_G (photos: NAIC Arecibo Observatory, a facility of the NSF).

The cable slips were measured at the tower and ground ends of the auxiliary cables after the first cable failure, and at the platform ends after the collapse (Figure 25). One-third of the cable slips exceeded the AASHTO limit of one-sixth of the cable diameter. The maximum cable slip was observed at the ground end of B12W, and had increased from 1.5 inches in May 2018 to over 1.75 inches in September 2020 (Figure 24).

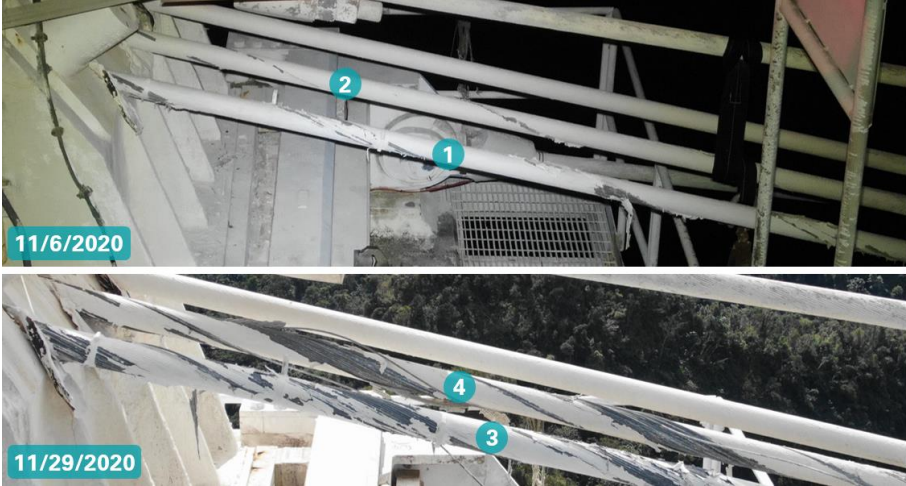
In the three weeks following the M4-4 failure, seven and five additional wires breaks were observed at the tower end of M4-1 and M4-2, respectively (Figure 27). The zinc casting of the M4-2 socket continued to deform with signs of crack movement at the back face of the casting (Figure 28).

- 1 Four wire breaks in M4-1
- 2 Two wire breaks in M4-2

Figure 27: Wire break development after second cable failure
(photos: NAIC Arecibo Observatory, a facility of the NSF).

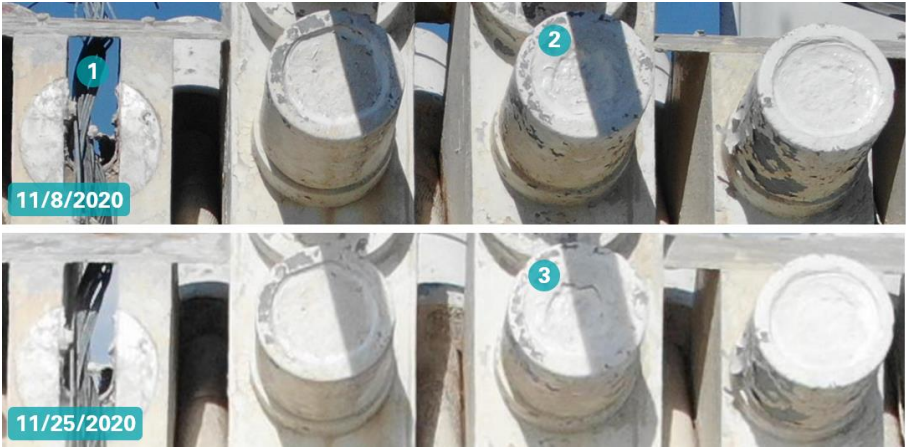
- 1 Failed end of M4-4 cable
- 2 Crack at back of M4-2_T zinc casting sealed before M4-4 failure

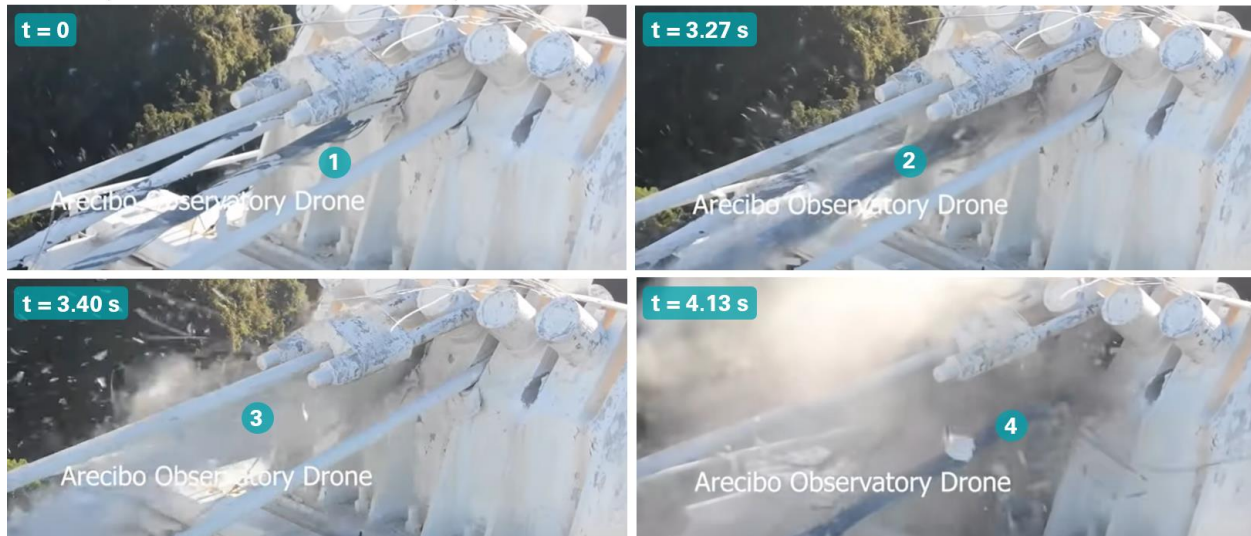
- 1 New wire break in M4-2
- 2 Complete failure of M4-2
- 3 Complete failure of M4-1
- 4 Complete failure of M4-3

Figure 29: Progressive failure of original main cables at top of Tower 4.
*(still images of drone video by NAIC Arecibo Observatory, a facility of the NSF.
 Intermediate still images are provided in Appendix E.)*

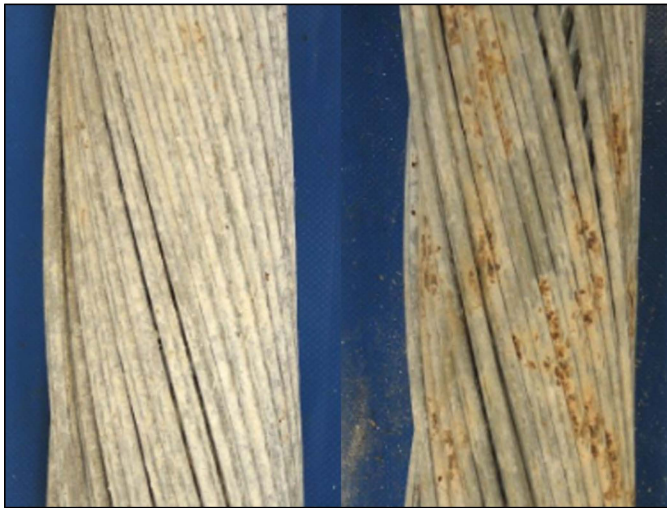
Figure 30: Oxidation of galvanizing zinc (left) and wire steel (right) in second wire layer of an original M4 cable (photos: Socotec).

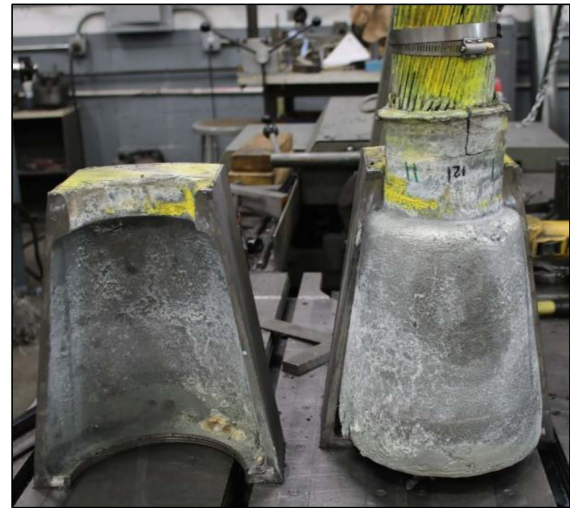
Figure 31: Surface corrosion of B12W_G socket casting (photo: Socotec).

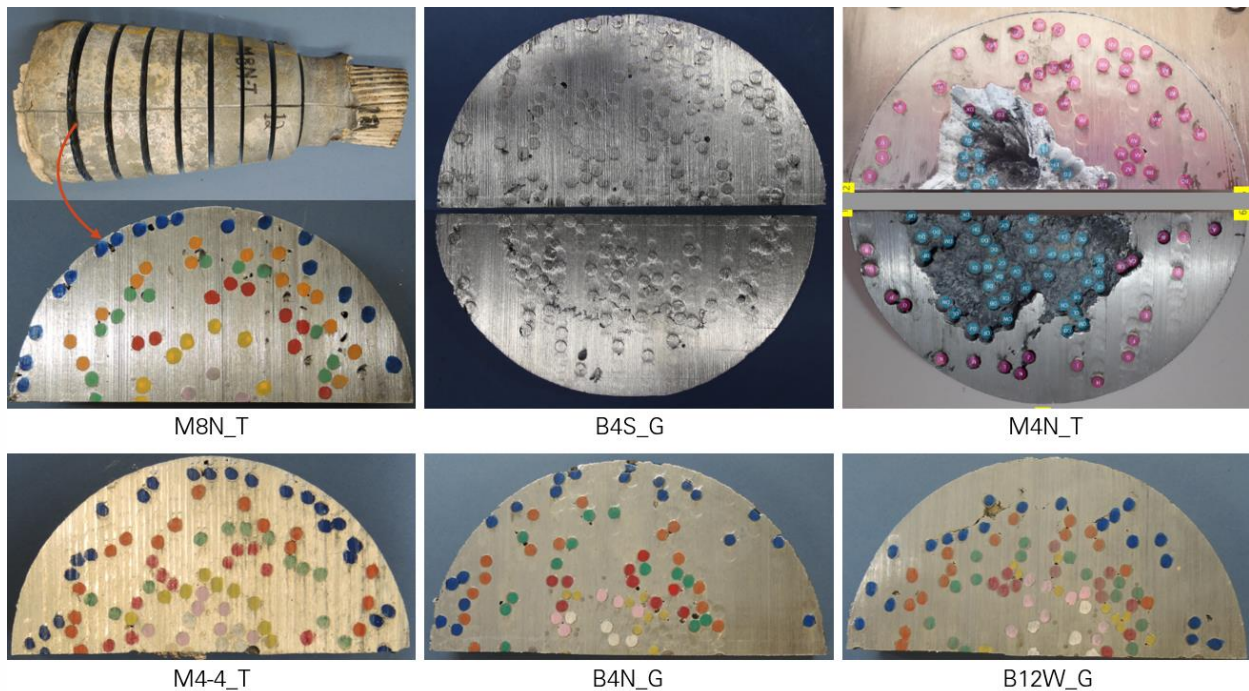
During socketing, the cable’s wires are spread out inside the socket to form a broom before pouring zinc. The casting of socket M4-4_T (second cable failure) and four auxiliary sockets (M8N_T, B4N_G, B4S_G, B12W_G) that exhibited different degrees of cable slip were cut in the transverse direction to observe the wire broom. As shown in Figure 32, the wire brooms are irregular, and differences in wire distribution between the center and perimeter of the casting can be observed. Additional observations and results on the wire broom geometry are provided in Appendix M.

Figure 32: Wire distribution at back of socket castings (M4N_T photos: WJE¹⁵; other photos: Socotec).

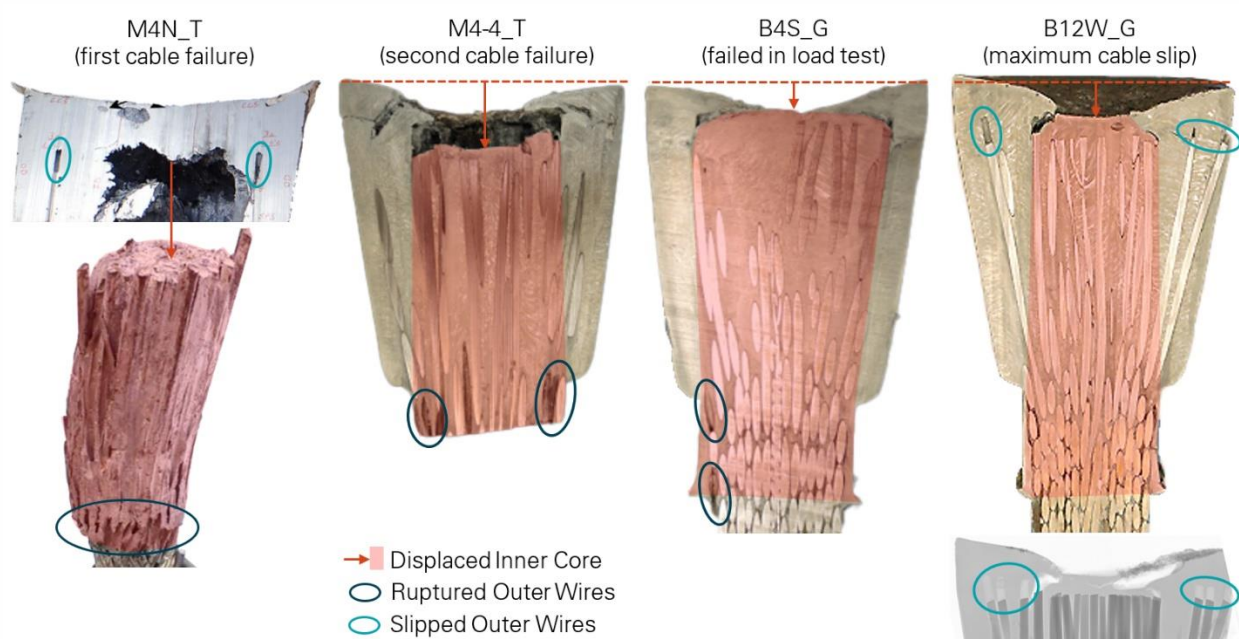
The inner core and the inner wires completely pulled out of the first socket that failed (M4N_T). In the second socket that failed (M4-4_T), the core remained in the socket after shifting significantly and the remaining wires ruptured outside of the core. As a result, the two failed sockets look different yet both failures started inside the socket with a displacement of the core and the rupture of outer wires (Figure 35).

Figure 33: Observations in distressed sockets (M4N_T photos: WJE¹⁶; B12W_G radiograph: Adrian Brügger, Columbia University - Oak Ridge National Laboratory; other photos: Socotec).

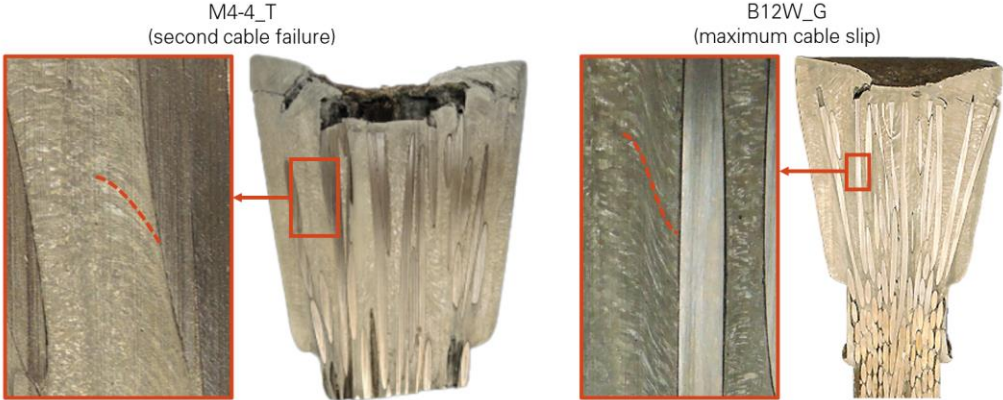
Figure 34: Evidence of grain flow near surface of displaced core in socket zinc casting (photos: Socotec).

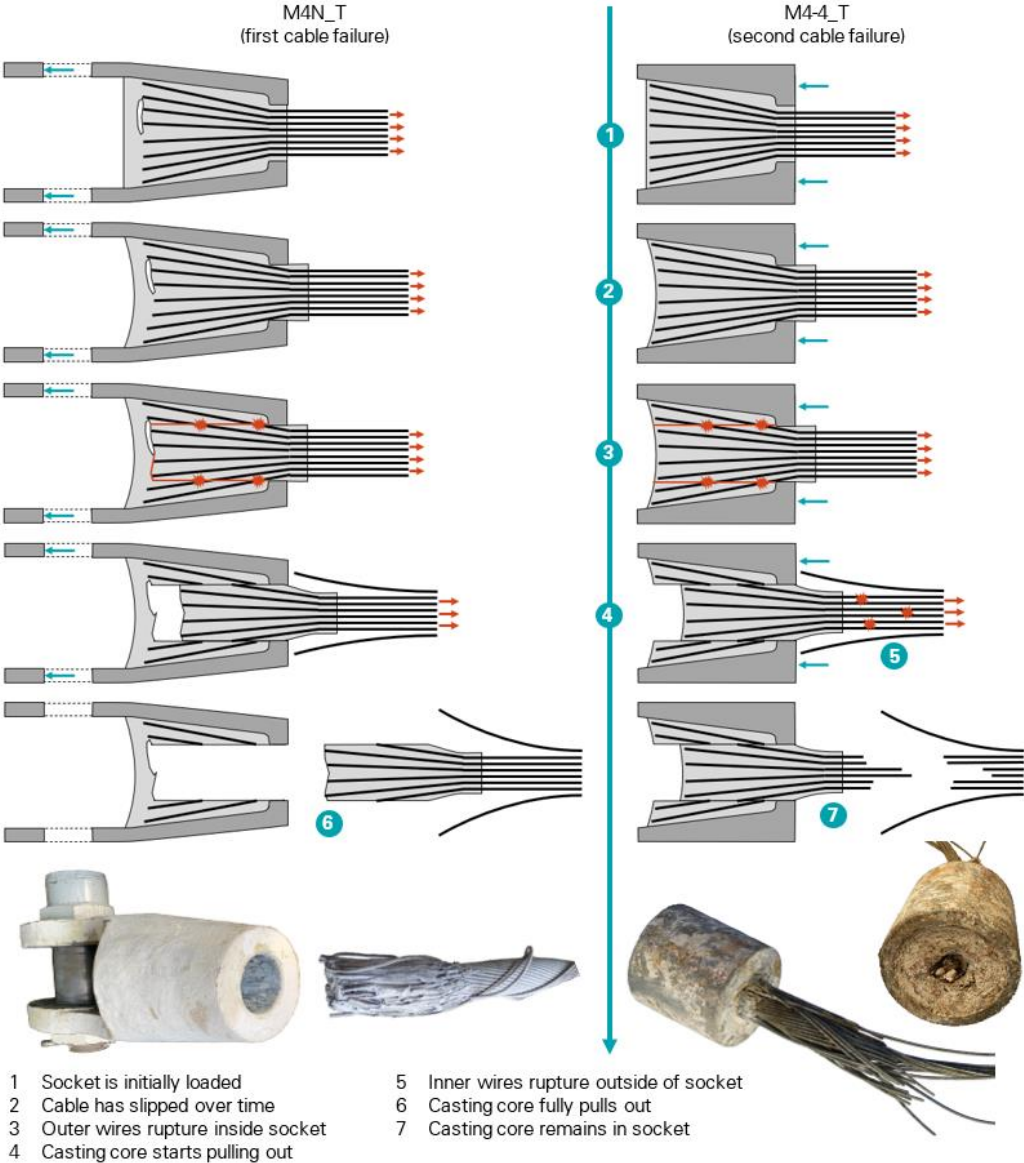
Figure 35: First two socket failures (M4N_T socket photo: NAIC Arecibo Observatory, a facility of the NSF; M4-4_T photos: Socotec).

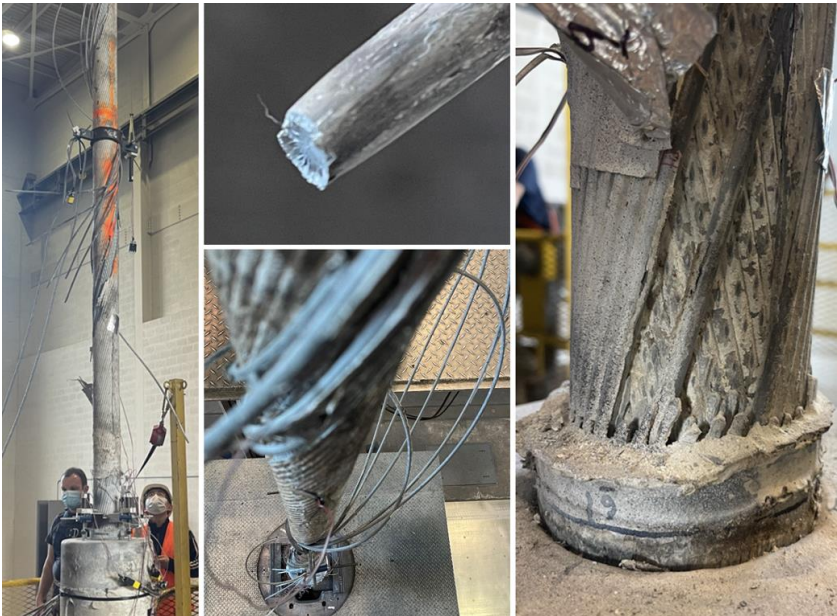
Figure 56: Failed wires in B4S_G socket at end of load test.
