Emergency Cleanup

**NOV
2021**
UPDATED
DEC 2021

The National Science Foundation (NSF), University of Central Florida (UCF), Arecibo Observatory, and a team of contractors are performing emergency cleanup activities after the collapse of the Observatory's 305-meter radio telescope on December 1, 2020.

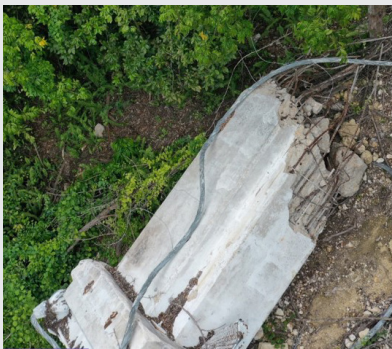
One of two fallen pieces of Tower 4 down the hill side

- Safely recovered two large concrete pieces from Tower 4 that had fallen down a slope as a result of the collapse, thereby preventing potential slippage down the hillside and implemented stormwater pollution prevention measures during this work, per the National Pollutant Discharge Elimination System Construction General Permit.

As part of the effort to retrieve two fallen pieces of Tower 4, NSF conducted informal consultation with USFWS to inform the planning for these emergency actions during May-June 2021. As a result, the team implemented measures to prevent loose soil from the construction of a temporary road from entering a nearby stream; conducted a tree and plant inventory to identify potential protected species; took measures to protect an identified rare fern; and followed protocols to protect the Puerto Rican boa. The retrieval effort is now complete and the site is being revegetated to its natural condition.

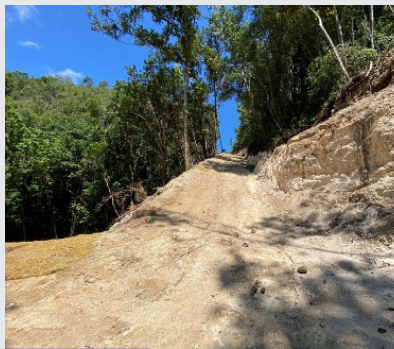
Tower 4 temporary access road

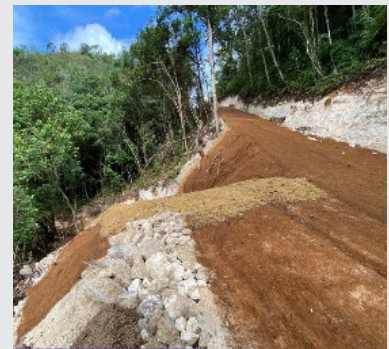
Erosion control measures after Tower 4 pieces recovered

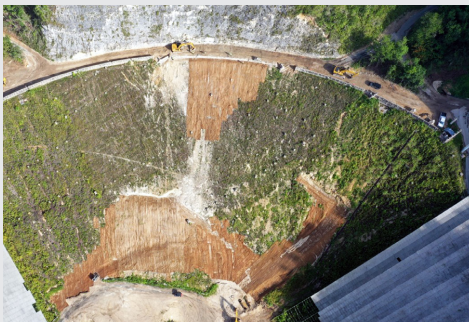
2 Rim wall repairs and erosion control measures

Once the fallen platform was removed (Figure 1), the team began repairing approximately 225 feet of concrete rim wall and installing erosion control measures, including the use of coconut fiber matting and seeding, to stabilize the slope under the reflector area and encourage native vegetation growth (Figure 2).

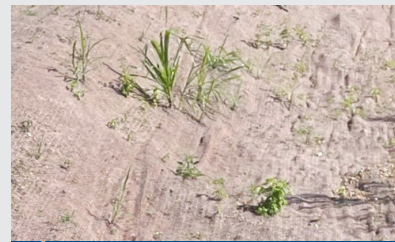
3 Coconut matting for site stabilization

The coconut matting provides a better substrate than bare soil because it encourages seed growth, anchors natural vegetation as it grows through the matting, and accelerates site stabilization (Figure 3).

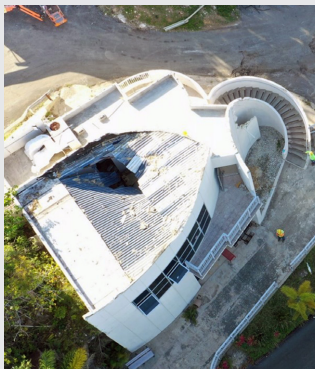
Because of the significant damage to the Learning Center roof caused by fallen cables (Figure 4), the team has installed a hurricane-proof temporary roof to stabilize and protect the structure until permanent repairs can be made (Figure 5). At the Science and Visitor Center (Figure 6), the repair of minor damage to the building's roof structure and observation deck roof has been completed.

4 Learning Center damage from collapse

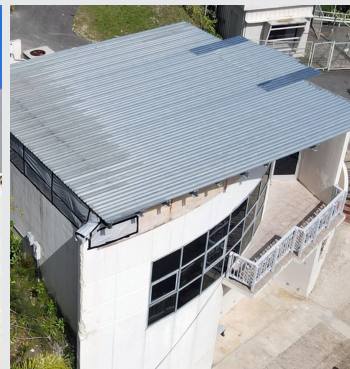
5 Learning Center temporary roof

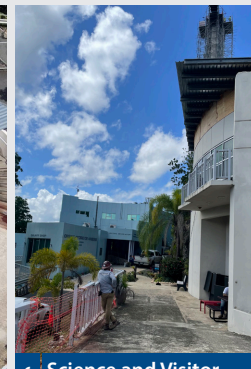
6 Science and Visitor Center area
