Draft Protected Species Mitigation and Monitoring Report

Juan de Fuca Plate Evolution and Hydration
in the Northeast Pacific Ocean

14 June 2012 - 8 July 2012

R/V Marcus G. Langseth

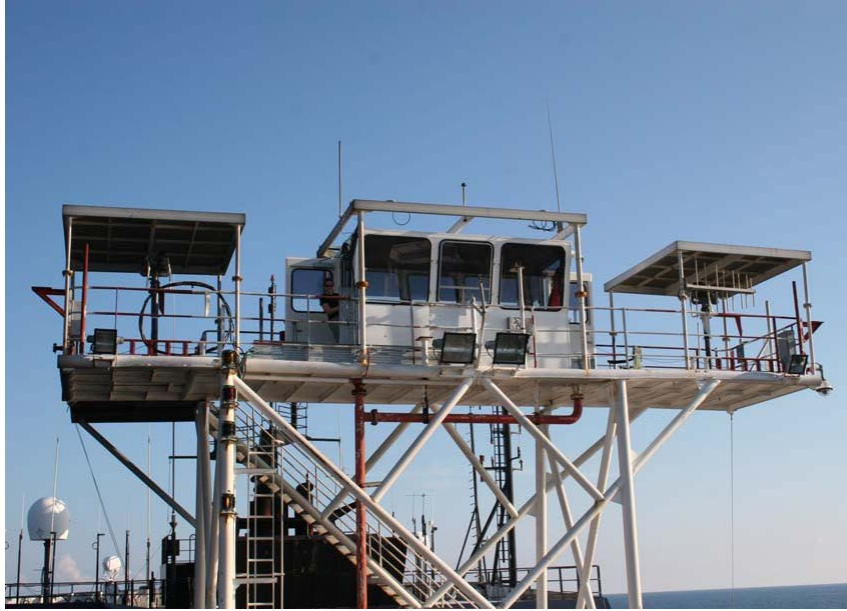
Figure 2. Protected Species Observer observation tower with mounted big-eye binoculars.

The PSO tower was equipped with Fujinon 7x50 binoculars as well as two mounted 25x150 Big-eye binoculars. Inside the tent located in the middle of the platform was a laptop for data collection as well as a telephone for communication with the PAM station, bridge, or main lab. Also inside the tent was a monitor that displayed current information about the vessel's position, speed, and heading, along with water depth, wind speed and direction, and source activity. Most observations were held from the tower; however, when there was severe weather or poor environmental conditions observations would be performed from the bridge (~12.8m above sea level) or the catwalk (~12.3m above sea level) in front of the bridge. Night Quest NQ2200 Night Vision Devices were also available to conduct night time observations for nighttime ramp-ups of the acoustic source, but were not used during this survey.

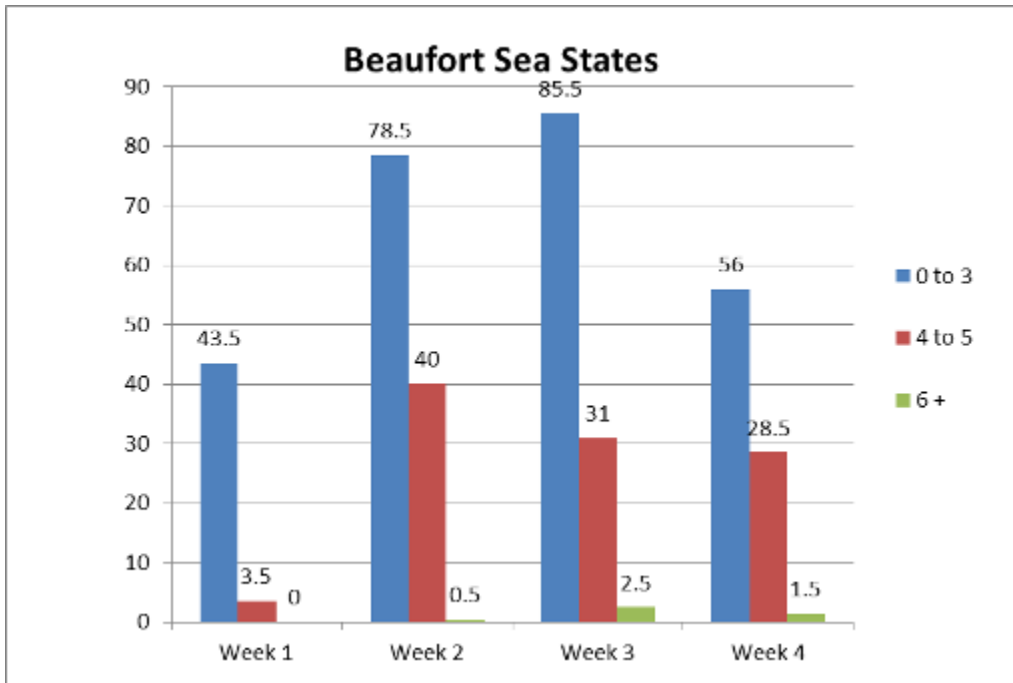
Figure 8. Beaufort sea state during visual monitoring over the marine geophysical survey.

The Beaufort sea state ranged from levels 0 through 6 but the average remained at a level 3 throughout the entire survey (Figure 8).

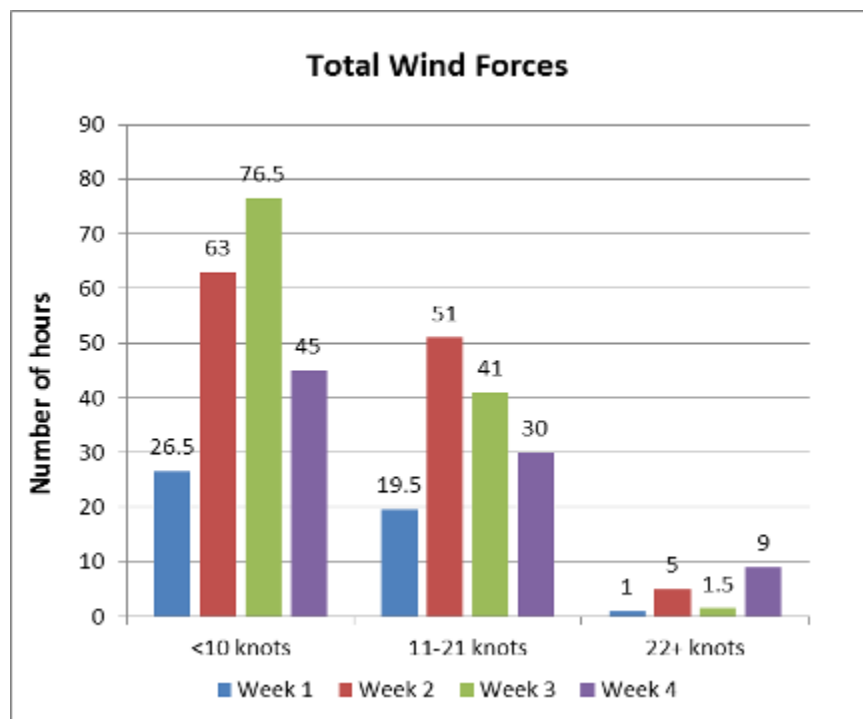
Figure 9. Average wind force each week during visual monitoring.

Wind forces remained relatively stable throughout the survey with a minimum of 0 knots present during weeks two, three and four; and a maximum of 29 knots during the fourth week. Forces less than 10 knots were present for 211 hours during the survey, and forces from 11-21 knots were present for 141.5 hours during the survey. Forces greater than 22 knots were only recorded for 16.5 hours during the survey, largely in the final hours of week four (Figure 9).

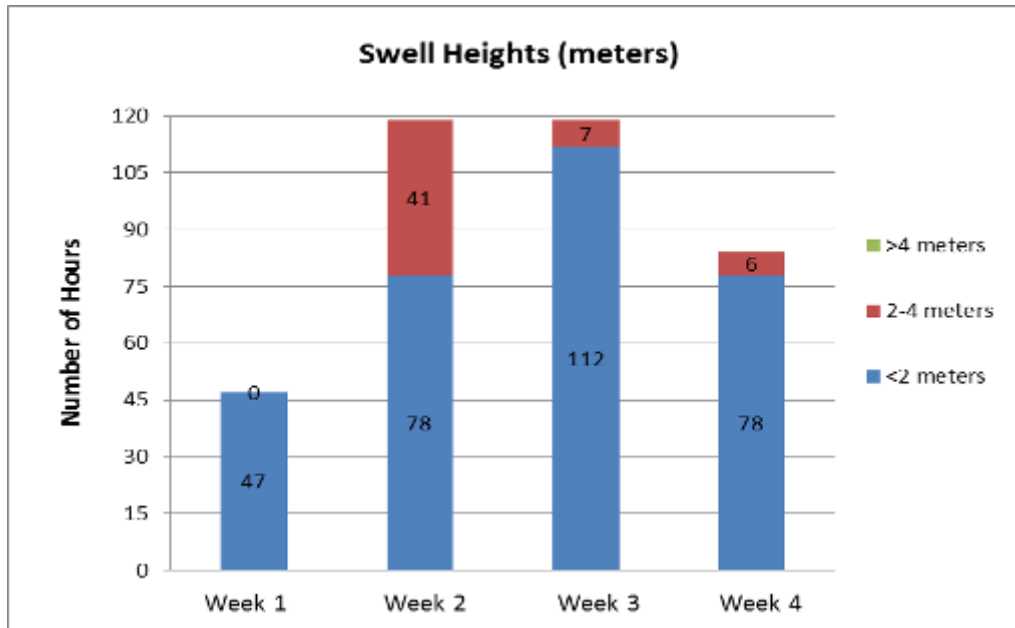
Figure 10. Swell heights while visual monitoring was conducted.

Swell height also remained relatively stable throughout the survey with 315 hours of swells under two meters, and only 54 hours of swells from 2-4 meters. There were no swells recorded over four meters (Figure 10).

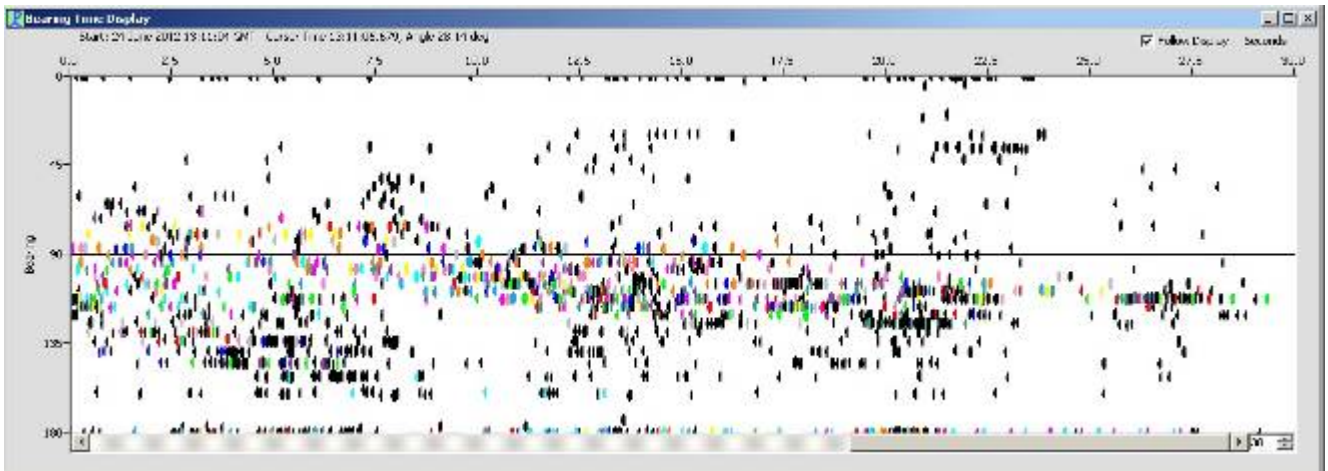
Figure 19. Multiple click trains from unknown number of Pacific white-sided dolphins shown on high frequency click detector on 24 June corresponding with visual detection 77 (acoustic detection 5).

(Figures 16, 17, 18, 19, 21, 22, 23 and 24) for all fourteen detections. Faint whistles were seen on the low frequency *Pamguard* spectrogram (Figure 21) and heard aurally on detections 6, 7, 10 and 11. Detections 1-5, 8-9, and 12-14 were not observed on the low frequency *Pamguard* Spectrogram or Whistle and Moan detector, or heard aurally by the PAM operator.

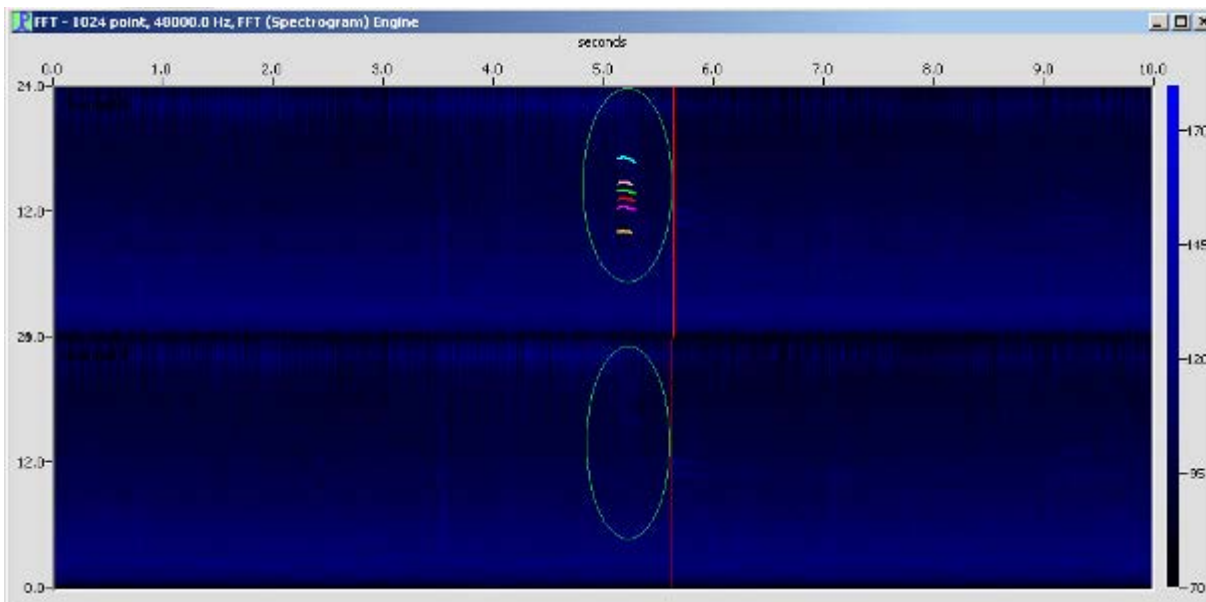
Figure 21. Low frequency whistles and clicks from Pacific white-sided dolphins shown on low frequency spectrogram on 2 July corresponding with visual detection 100 (acoustic detection 10).

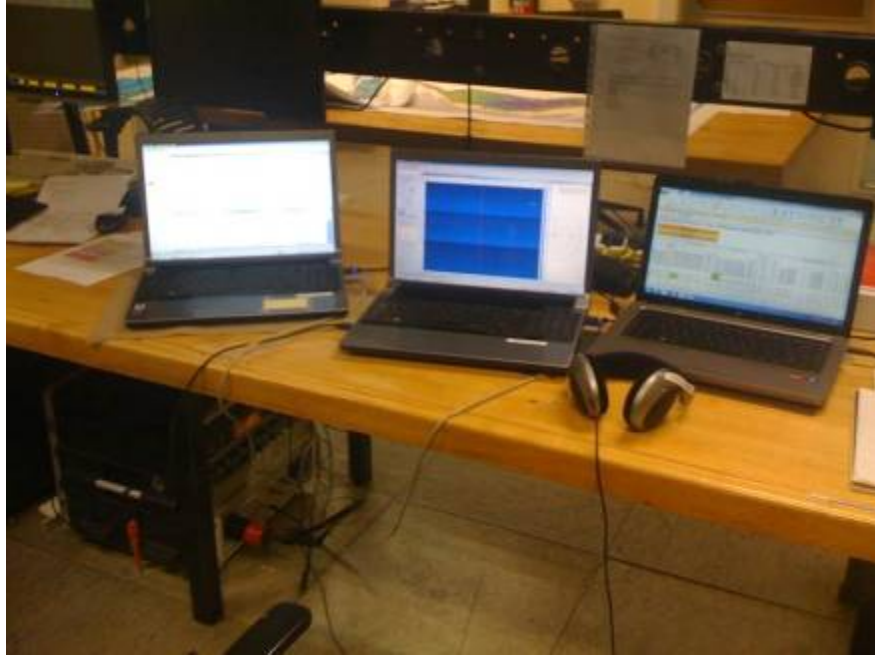
Figure D.2: PAM Laptops and data processing unit setup.

The two laptops and data processing unit are set up in the main lab with a GPS cable feed (INGGA string) directly from the ship’s navigation system to the low frequency laptop (Figure D. 2). The data processing unit connects to the 250m hydrophone cable through a 100m deck cable that is run from the main lab out to the gun deck. Both the deck cable in use and the spare are run from the main lab out to out to the gun deck just in case one failed because the cable had to be run through the bulk head which can only be done while in port. The 250m hydrophone cable is wound on a section of a deckhead winch on the port side of the gun deck (Figure D. 3). From the winch the hydrophone cable is fed astern and pulled further port by a line secured by a yale grip to the port sponson. (Figure D.4). An 8m rope drogue was secured to the end of the hydrophone cable with zip ties with a 9kg shackle secured to the end of the rope drogue with a knot and tape (Figure D.5). Second four lengths of chain weighing approximately 2.5kg each were secured on the cable with tape, 3m, 45m, 96, and 132m up from the depth gauge (Figure D.6). The hydrophone is deployed approximately 150m from the stern and 50m before the center of string. Being that the hydrophone cable is free and independent of the guns the cable is always retrieved before port gun strings are moved.

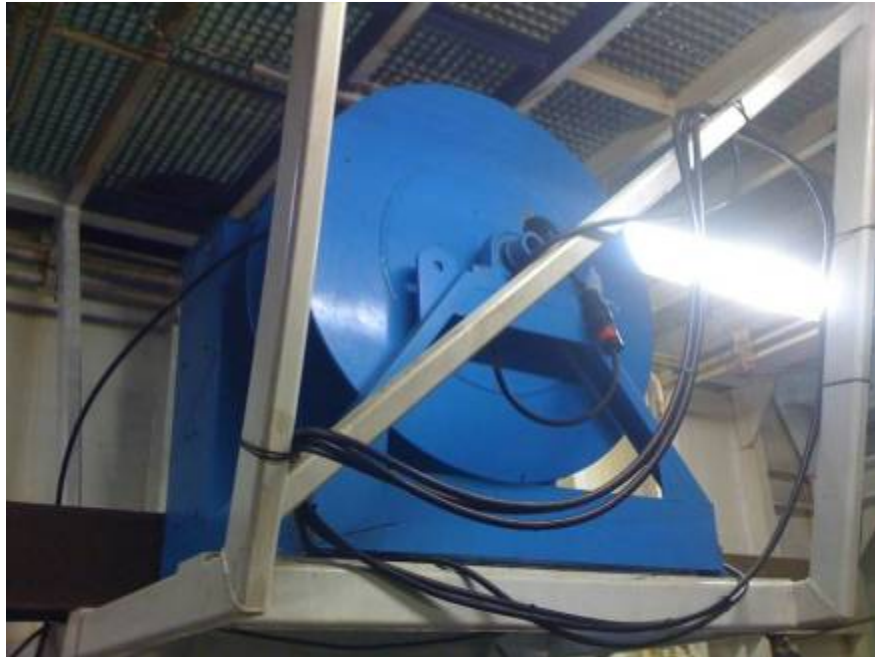
Figure D.3: Hydrophone cable on winch.

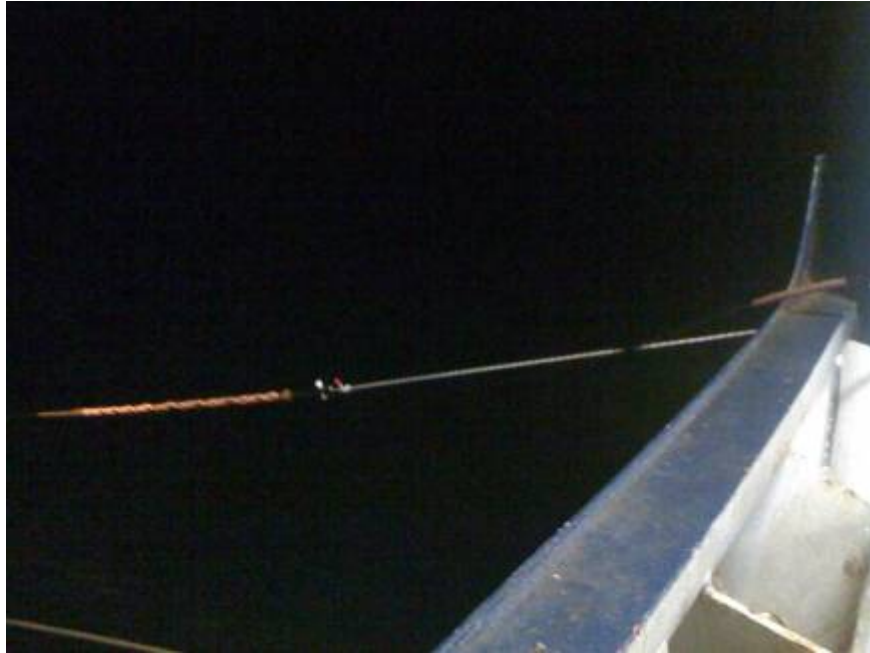
Figure D.4: Hydrophone cable secured by a yale grip to the port sponson.

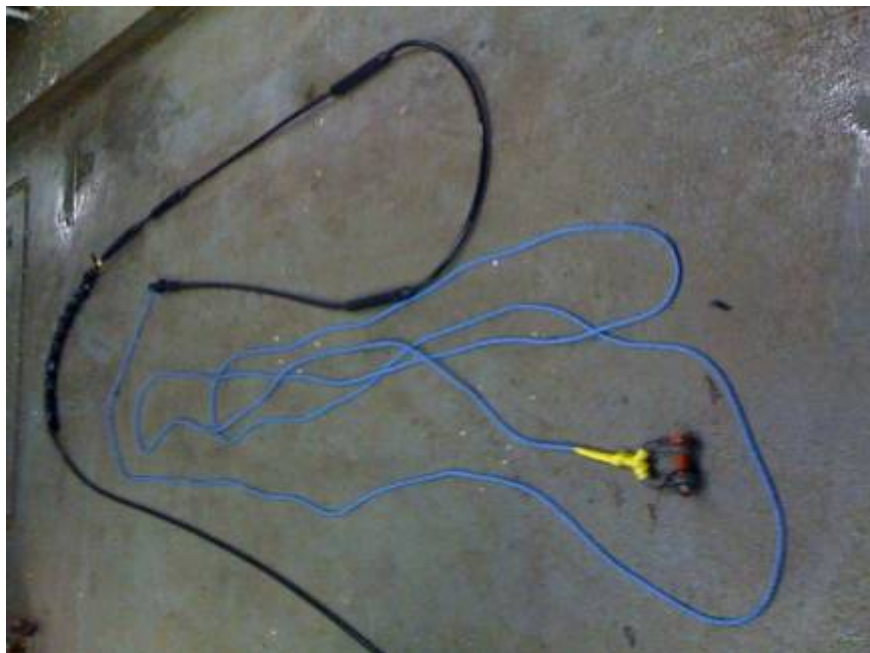
Figure D.5: Rope drogue and first chain weight secured near hydrophone elements.

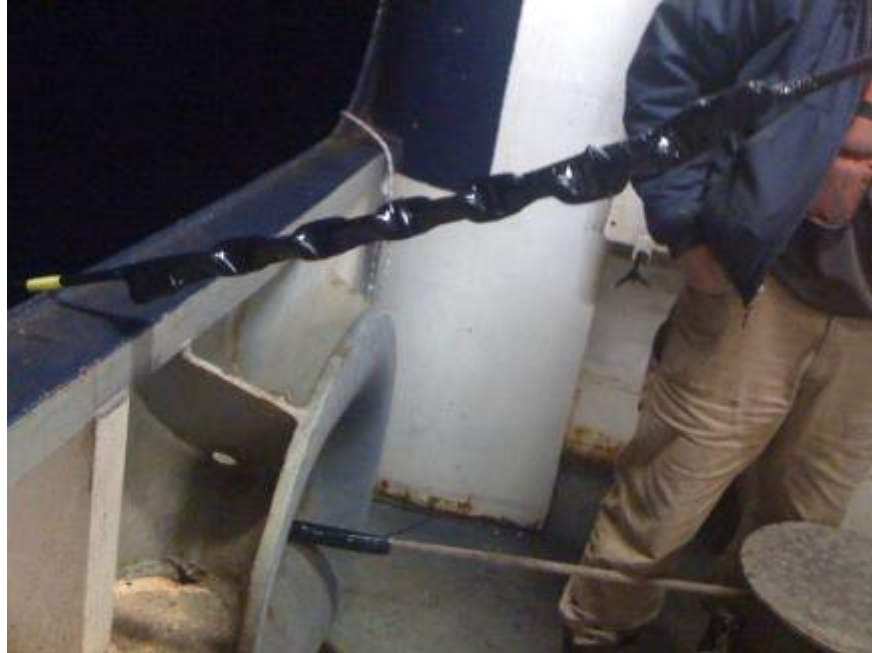
Figure D.6: One of the four lengths of chain used to weigh down the cable.
