Protected Species Mitigation and Monitoring Report

**3-D Seismic Survey
in the Northwest Atlantic Ocean off New Jersey**

1 July 2014 – 23 July 2014

R/V Marcus G. Langseth

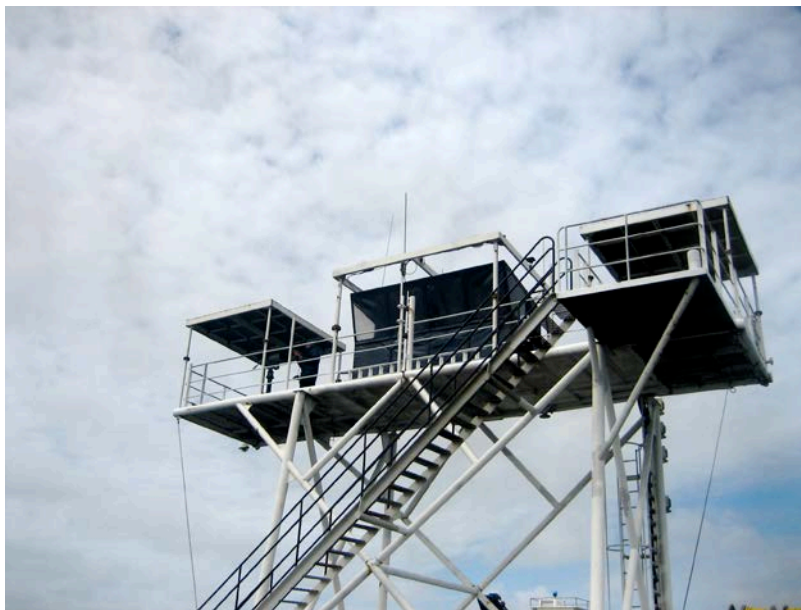
Figure 2. Protected Species Observer observation tower with mounted big-eye binoculars

The PSO tower was equipped with Fujinon 7x50 binoculars as well as two mounted 25x150 Big-eye binoculars. Inside the tent located in the middle of the platform was a laptop for data collection as well as a telephone for communication with the PAM station, bridge, or main lab. Also inside the tent was a monitor that displayed current information about the vessel's position, speed, and heading, along with

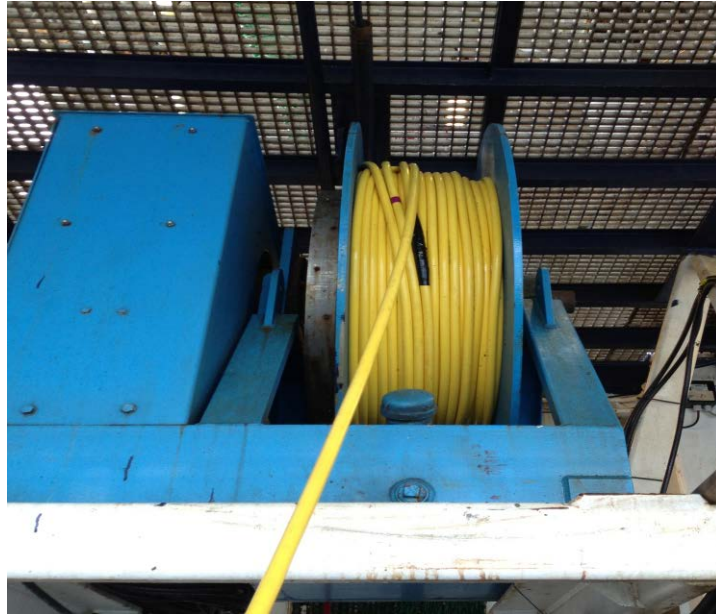
The hydrophone array cable, connected to the tow cable, is spooled onto a port hydrolytic winch (Figure 2). The adjoined cables are deployed directly off the stern of the vessel, just aft of the winch. The hydrophone tow cable, with a looped rope attached via Chinese-fingers bound by tape, connects to a tow rope with shackle and this is the towing point of the PAM cable system (Figure 3; Left). The towrope is secured to a bitt aft of the winch and run through a chalk (Figure 3; Right) where it connects to the PAM cable.

Figure 2. PAM tow cable spooled onto the winch and running aft.

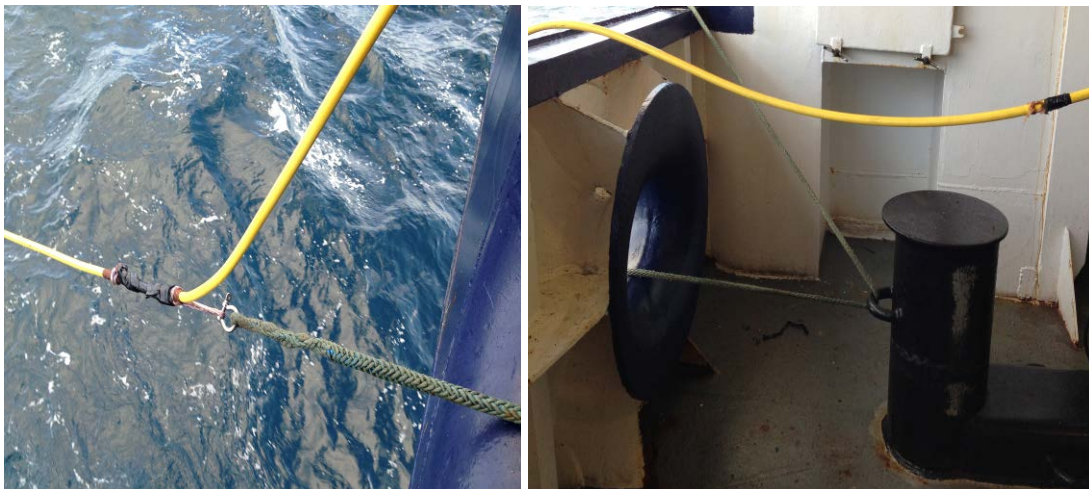
Figure 3. On the left is the PAM tow cable connecting to the towrope via shackle. Right shows PAM going over the stern bulkhead, the towrope tied off to the bitt and threaded through the chalk.

To ensure a lower placement of the PAM cable in the water column than the adjacent gun cables, 2.5kg of weight is added to the cable.

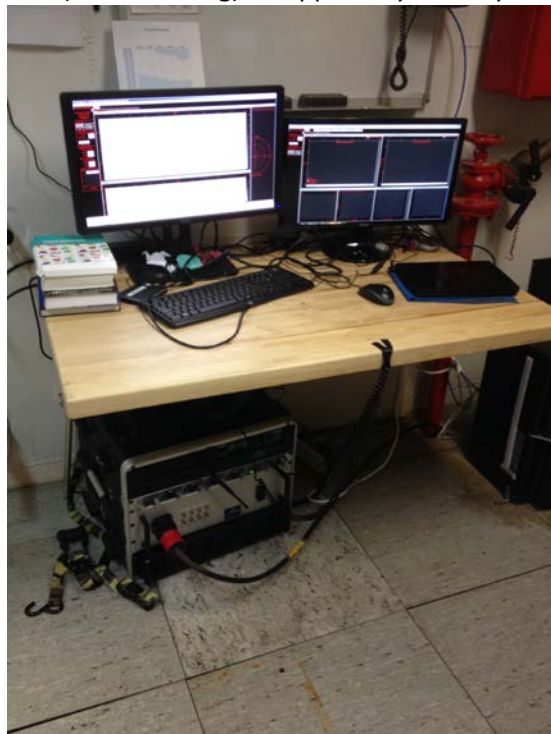
The PAM data processing unit and monitors are setup and secured for rough weather in the main science lab (Figure 5). A GPS feed (GPGGA string) is supplied by the ships navigation system Seapath 200.

Figure 5. Passive acoustic monitoring station located in the instrument room.
