Arecibo Telescope Collapse Forensic Investigation

Thornton Tomasetti

July 25, 2022

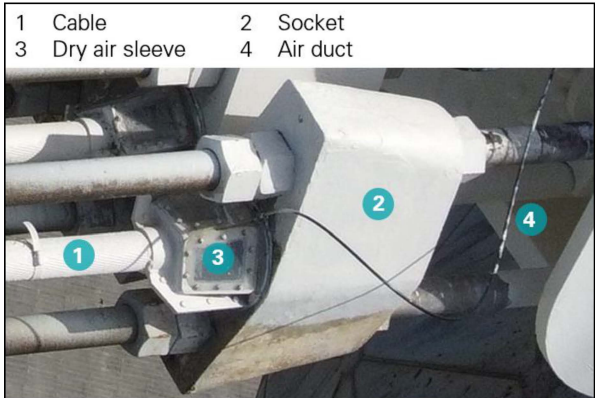
In the late 1960s, AO observed that the cables were not fully airtight in the transition zone between cable and socket, and determined that this could lead to corrosion within the cable due to moist air intrusion and condensation. In 1972, a system of sleeves, air compressors and dryers was installed at the lower end of the cables to circulate dry air through the cables and prevent accumulation of moisture (Figure 9). The same moisture exclusion system was installed on the auxiliary cables during the second upgrade in 1997. While the system appeared to be functional, condensation was occasionally reported in some of the dry air sleeves between 2002 and 2011. We also observed water accumulation in some of the dry air sleeves during our site visits before and after the collapse.

Figure 9: Dry air sleeve on M8-1_P socket
(photo: NAIC Arecibo Observatory, a facility of the NSF).

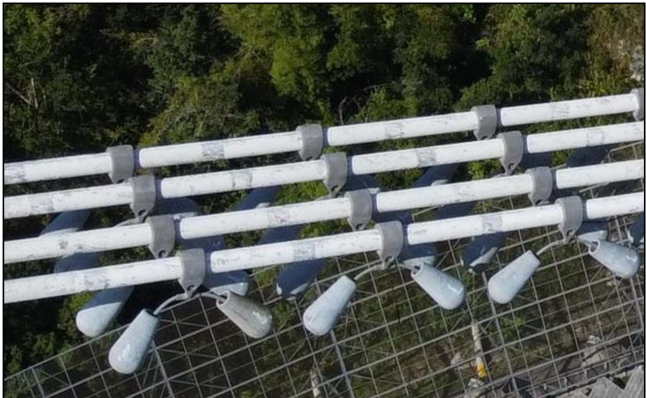
The cables of the telescope experienced wind-induced vibrations immediately after construction in 1964. Stockbridge dampers (Figure 10) were installed to mitigate the vibrations and appear to have been effective, even though vibrations continued to be reported between 1970 and 2011. The vibrations were

Figure 10: Stockbridge dampers on original M4 cables
(photo: NAIC Arecibo Observatory, a facility of the NSF).

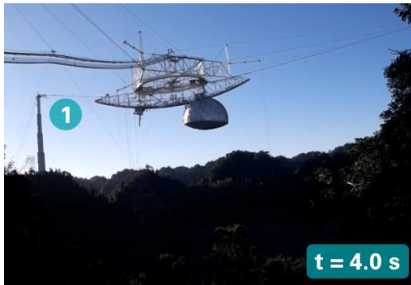
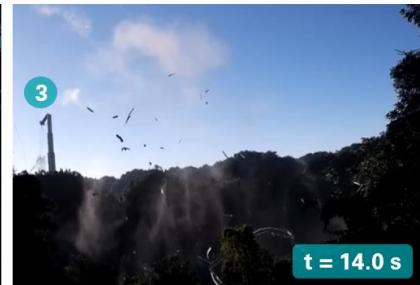
Figure 19: Telescope collapse sequence, looking south.
 (Still images of collapse video by NAIC Arecibo Observatory, a facility of the NSF.
 Intermediate still images are in provided Appendix E.)

1 Main cables fail at top of Tower 4

2 Platform swings down and azimuth arm detaches

3 Tower top breaks off

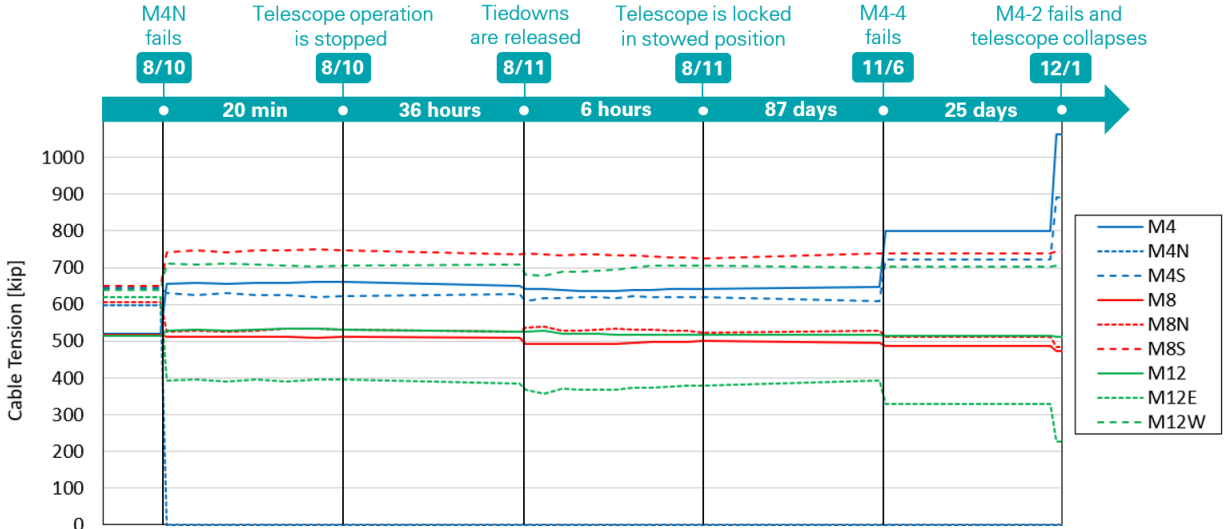
The M4N failure had a more significant impact on the redistribution of cable tensions than the M4-4 failure. Since M4N was an isolated cable, its failure resulted in an imbalance in the suspended structure. The suspended structure rotated to reach a new balance state resulting in increased and decreased tensions in the rest of the cable system. M4-4 ran in parallel with three other original M4 cables. As a result, when M4-4 failed, its tension was primarily redistributed to the three other M4 cables.

Figure 43: Tension in main cables between first cable failure and collapse.

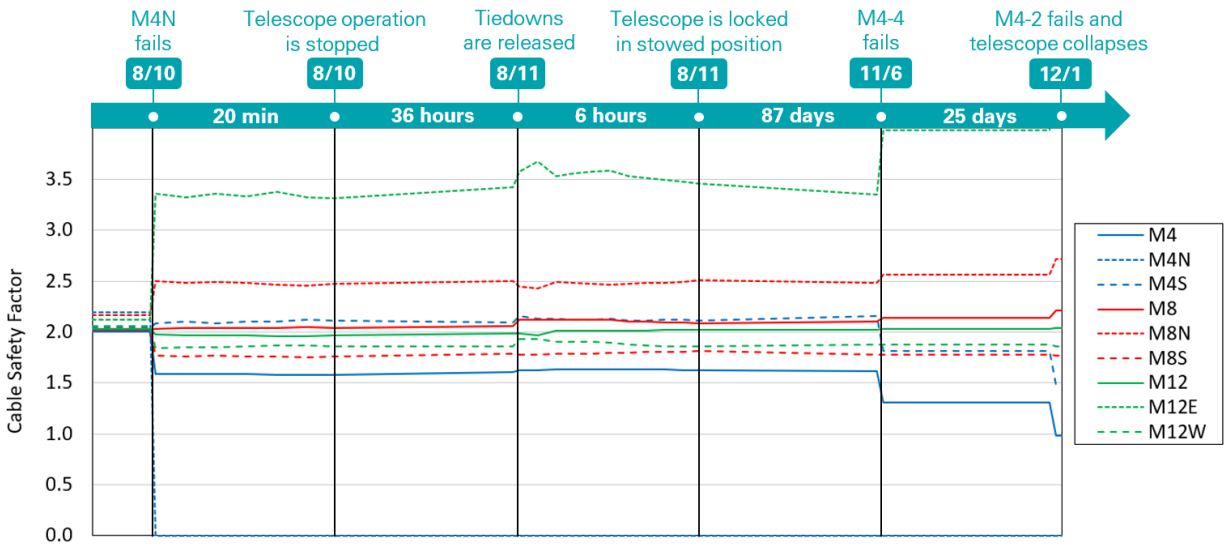
Figure 44: Safety factor in main cables between first cable failure and collapse.

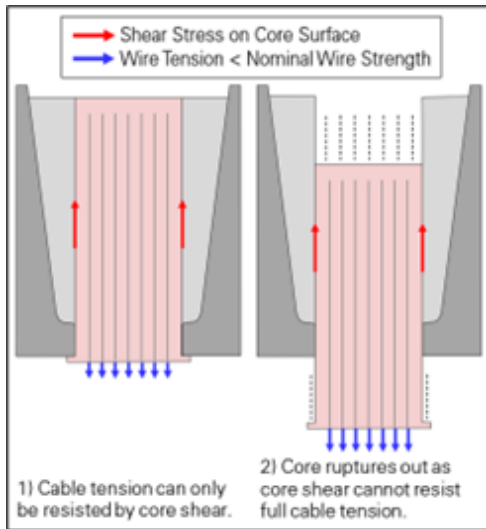
A key parameter affecting the cable slip is therefore the wire broom geometry, which includes the number of crossing wires, their length outside of the core, and their orientation with respect to the core surface. If a cable was not broomed out, the cable tension could only be resisted in shear on the core surface (Figure 46). This would result in rapid zinc flow, zinc shear failure and/or cable slip from the zinc. In any case, the cable would slip out of the socket under any substantial tension. Conversely, when the cable is broomed out, the crossing wires stretch and pick up more tension as the cable slips due to zinc flow (Figure 47). The increased tension in the crossing wires decreases the shear stress on the core, which slows down and effectively stops the zinc flow and cable slip. This, however, is only possible if the crossing wires have a sufficient capacity collectively to resist the full cable tension.

Figure 46: Case 0 – Core rupture in absence of wire broom.

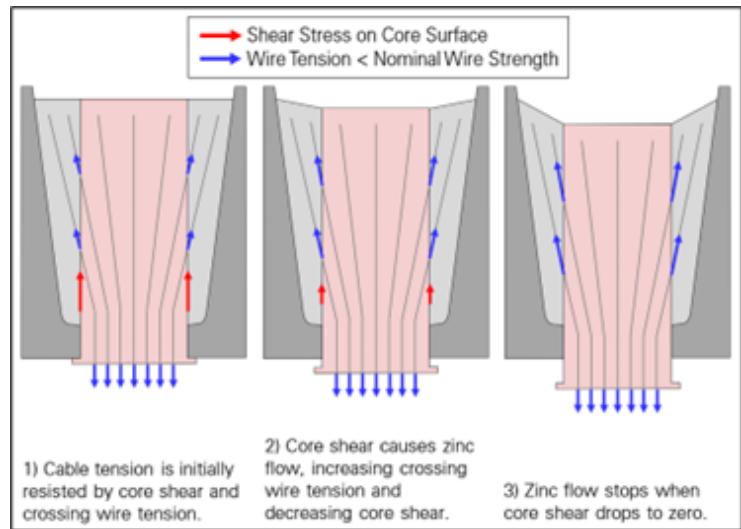
Figure 47: Case 1 – Limited cable slip when crossing wires can resist full cable tension.

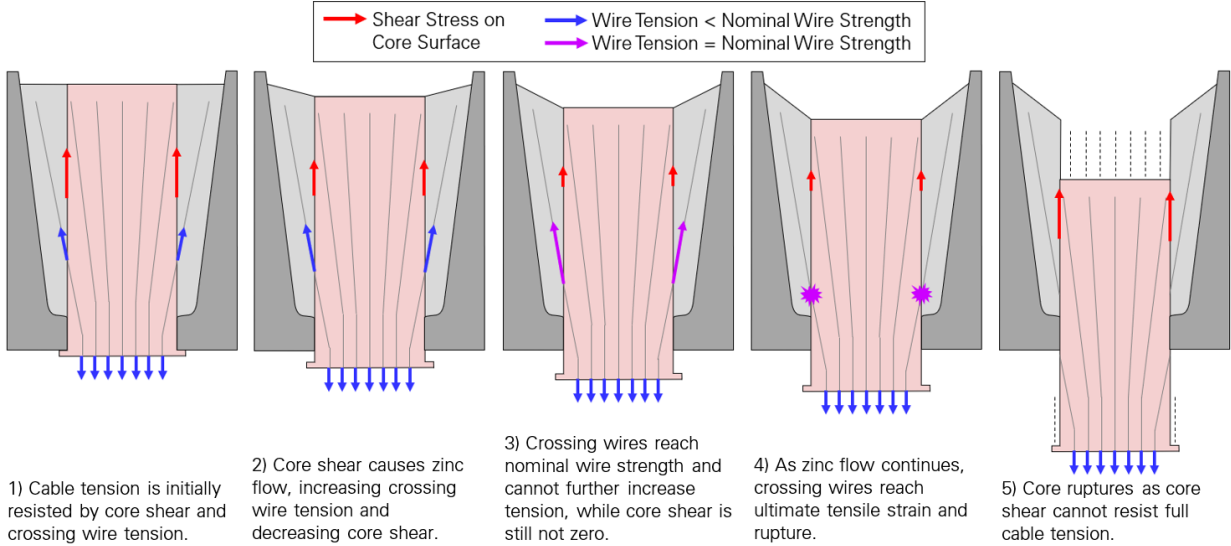
A socket where the crossing wires cannot resist the full cable tension is bound to fail, and the socket's failure mode depends on whether the crossing wires are fully or partially developed. If the crossing wires are fully developed (Figure 48), they continue to stretch near the core surface as the zinc continues to flow. Some of the wires rupture when they reach their ultimate tensile strain, which increases core shear and accelerates zinc flow, leading to more wire ruptures and, eventually, to *core rupture*. If the crossing wires are partially developed, they can slip in parallel with the core instead of rupturing, leading to *core flow-out* (Figure 49). In this case, the cable continues to gradually slip out of the socket. Complete slip-out or rupture of the core will eventually occur as the contact length between cable and socket decreases and/or the zinc's strain becomes too large. Macroscopically, the socket failure is more brittle when the crossing wires are fully developed, and more ductile when the crossing wires are partially developed. Actual sockets may include both fully and partially developed crossing wires and therefore exhibit intermediate behaviors and failure modes (Figure 50).

Figure 48: Case 2 – Core rupture when crossing wires cannot resist full cable tension and are fully developed.

Four of the six sockets that were analyzed failed or were in the process of failing. The failures of sockets M4N_T and M4-4_T occurred in the field and involved the rupture of multiple outer wires and a significant shift or complete pull-out of the core, which corresponds to core rupture (Figure 48, page 35). The load test of socket B4S_G was stopped after seven outer wires ruptured, indicating that the socket was on the brink of core rupture. Finally, socket B12W_G experienced a very large cable slip as its crossing wires slipped without fracturing, which corresponds to core flow-out (Figure 49 page 35).

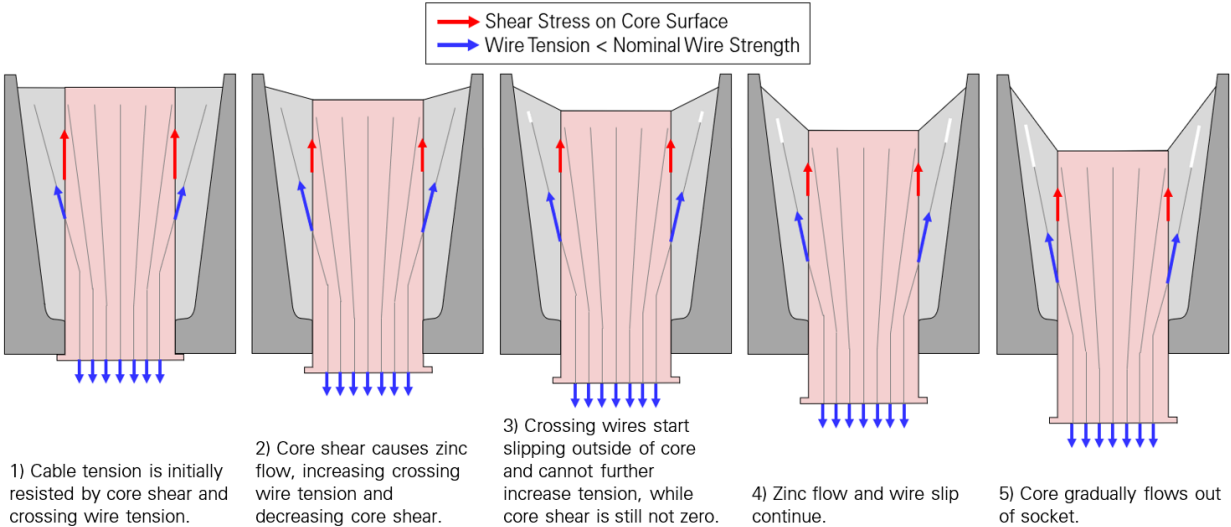
Figure 49: Case 3 – Core flow-out when crossing wires cannot resist full cable tension and are partially developed.

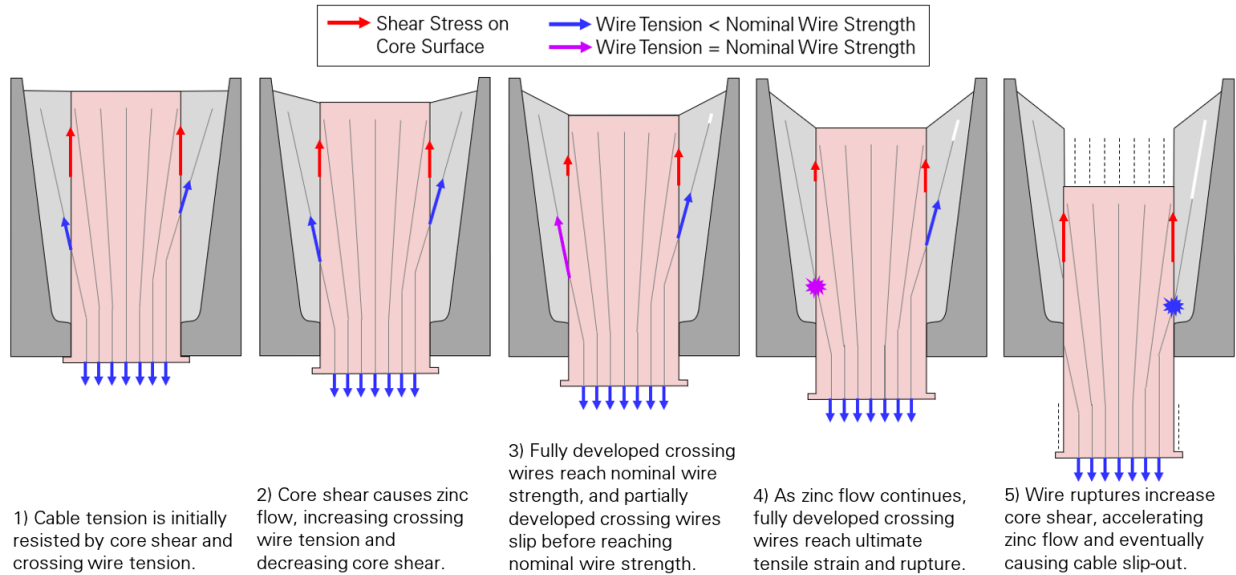
Figure 50: Case 4 – Socket failure when crossing wires cannot resist full cable tension and include both fully and partially developed wires.

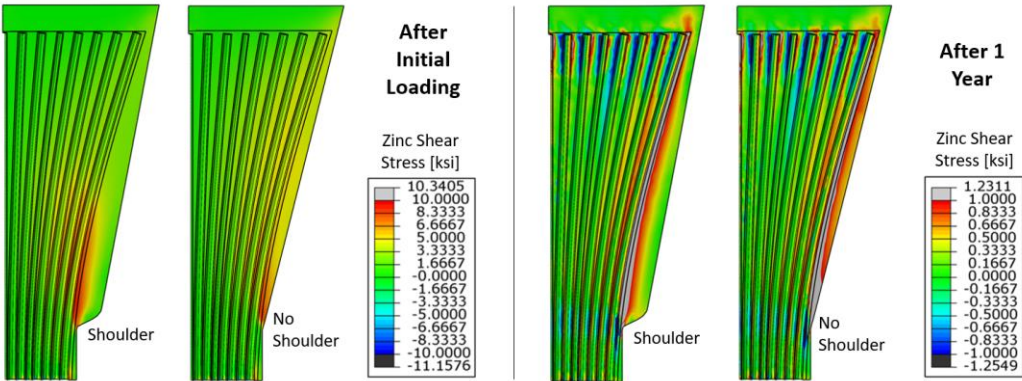
The initial loading causes higher shear stress at the front of the zinc casting, as the load is partially resisted in bearing on the shoulder (Figure 52). However, after one year of zinc flow, the shear stress distribution is similar in the castings with and without a shoulder. The wire stresses are also similar in the two models.

Figure 52: Shear stress in zinc casting with and without shoulder.

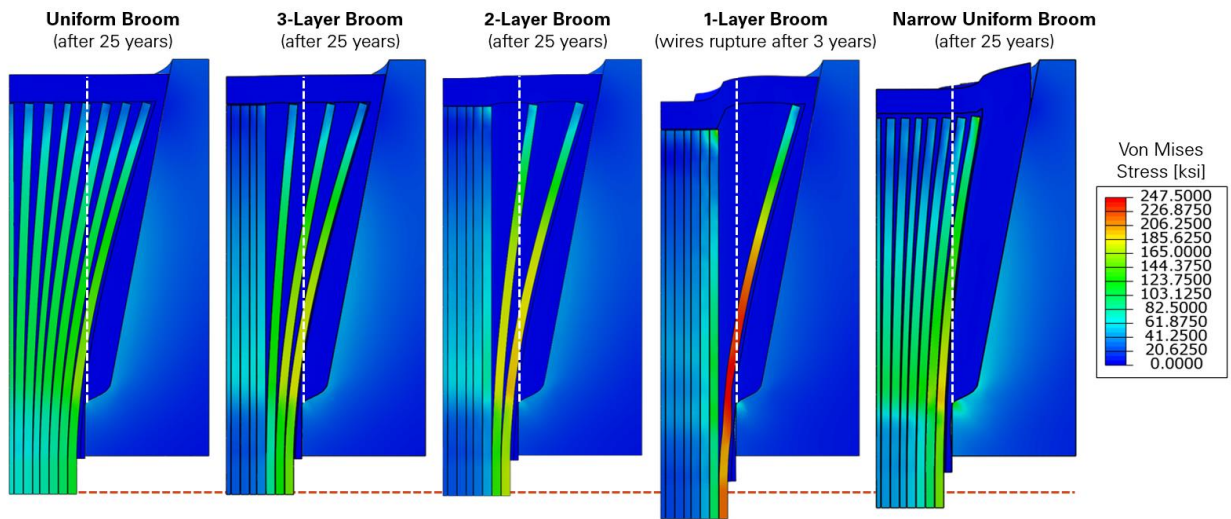
In the cable modeled with the socket, the two outermost wire layers account for 48 percent of the cable's section area. Those two layers are therefore sufficient to resist most or all of the applied load, which is 50 percent of the cable's minimum breaking strength. With that in mind, the FE analysis results (Figure 53, Figure 54) are consistent with the socket behavior previously introduced (Figure 47 vs. Figure 48, pages 34 to 35): if the full cable tension can be resisted by the broomed-out wires (uniform, three-layer and two-layer brooms), zinc flow stops and the socket does not fail and shows limited cable slip. In contrast, if the broomed-out wires cannot resist the full cable tension (one-layer broom), zinc flow and cable slip continue over time and eventually cause the socket to fail. As wire slip within the zinc was not modeled, the wires and the core ruptured in the FE model.

Figure 53: Cable slip and wire stress for different idealized wire brooms after 25 years of zinc flow.

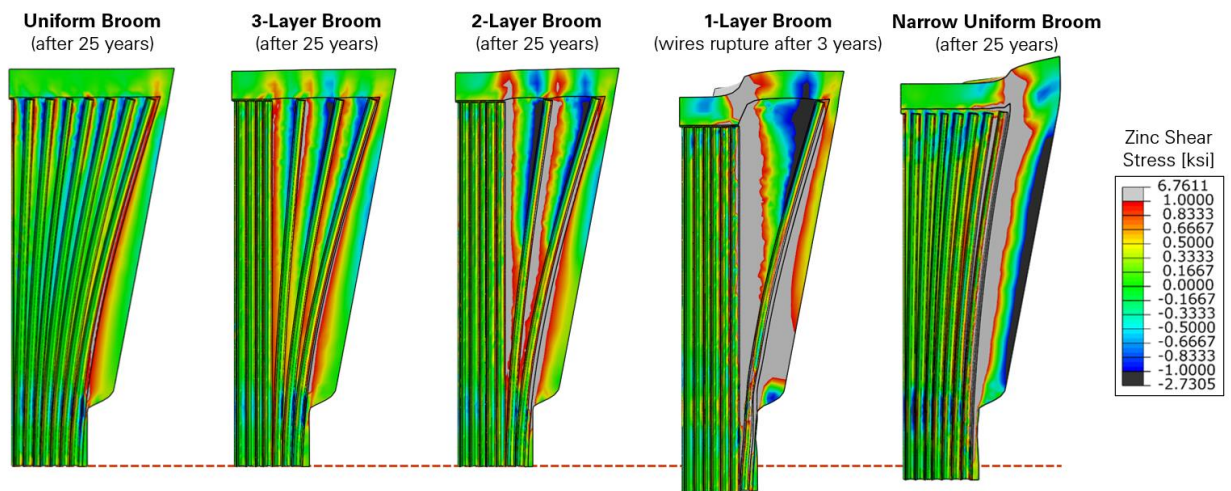
Figure 54: Zinc shear stress for different idealized wire brooms after 25 years of zinc flow.

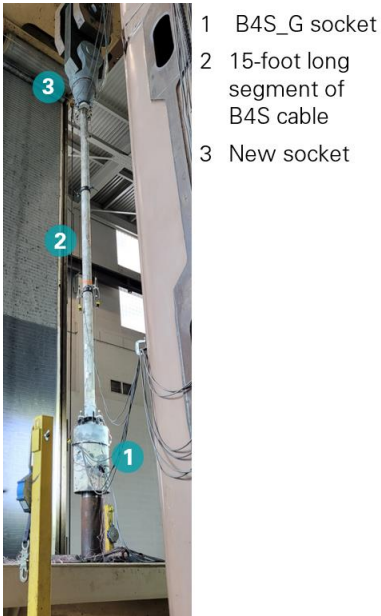
Socket B4S_G was recovered from the collapsed telescope with 15 feet of cable attached. The socket was generally in good condition, had no visible wire breaks, and exhibited an intermediate cable slip of 0.875 inch. The free end of the cable was cast in a new zinc-filled spelter socket, and the specimen was installed in a test frame (Figure 55).

Figure 55: Socket and cable specimen in load testing machine.

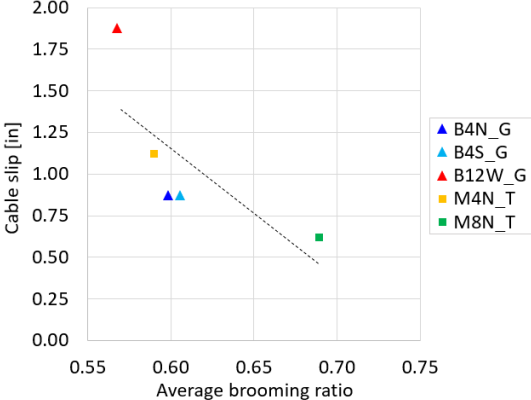
To characterize the broom geometry, we define a wire’s *brooming ratio* as the wire’s distance to the central axis (*r*) divided by the casting’s radius (*d*) in the plane containing the wire ends (Figure 63). For the five auxiliary sockets considered, the cable slip decreases as the average brooming ratio increases (Figure 64). This result is a first general correlation between wire broom and cable slip, which was further investigated.

Figure 64: Cable slip vs. average brooming ratio for five auxiliary sockets.

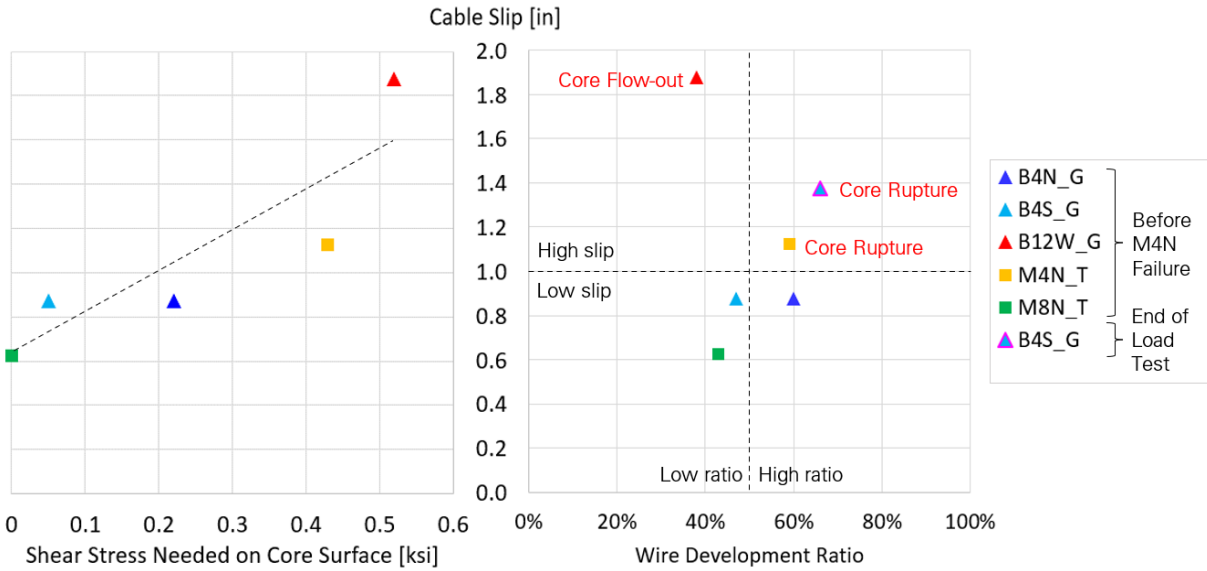
Under gravity loads, the cable slip increases with the shear stress needed for the five auxiliary sockets (Figure 65 left). In addition, when the first cable failed, the shear stress needed in socket M4-4_T increased from zero to the largest stress (0.7 ksi) among all considered sockets as the M4 cables experienced a 30 percent increase in tension. Socket M4-4_T failed three months later, and fracture

Figure 65 summarizes the observed socket behavior: if shear stress is needed on the core surface to resist the full cable tension, the zinc flows and causes cable slip over time. When the cable slip becomes too large, the socket fails in core rupture or core flow-out depending on whether the crossing wires are primarily fully developed or partially developed.

Figure 65: Correlation between core shear stress, wire development ratio, cable slip, and socket failure.

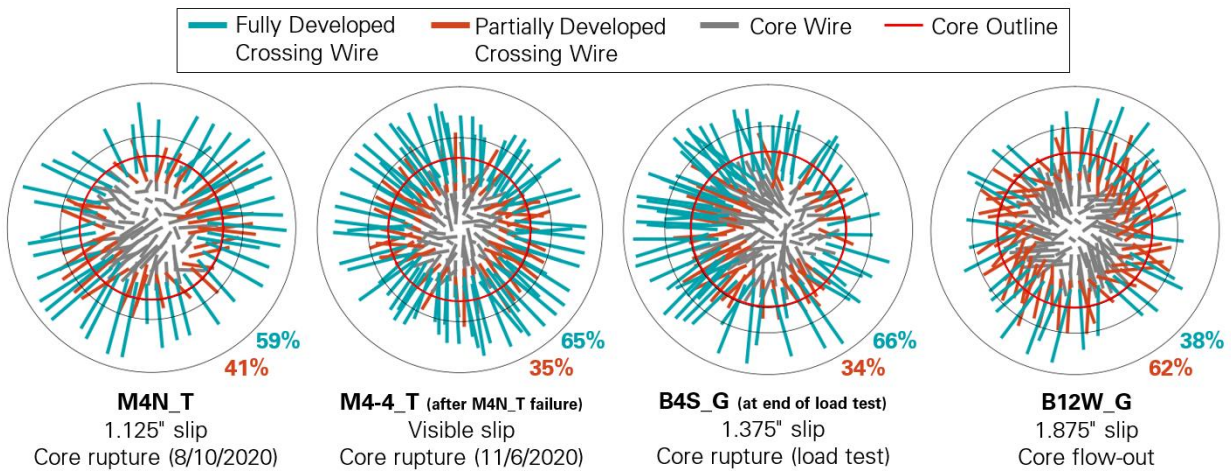
The three sockets exhibiting core rupture had a larger wire development ratio (59 to 66 percent) than the socket exhibiting core flow-out (38 percent) (Table 6, Figure 65 right, and Figure 66). This result is consistent with the socket behavior previously introduced (Figure 48 vs. Figure 49, page 35): fully developed wires lead to core fracture, while partially developed wires lead to core flow-out.

Figure 66: Fully and partially developed crossing wires in failed and failing sockets.
